**Jefferson Proving Ground  
South of the Firing Line**

**Final Asbestos Survey Summary Report**

**Volume III  
(Buildings 230 through 475)**

**September 1993**

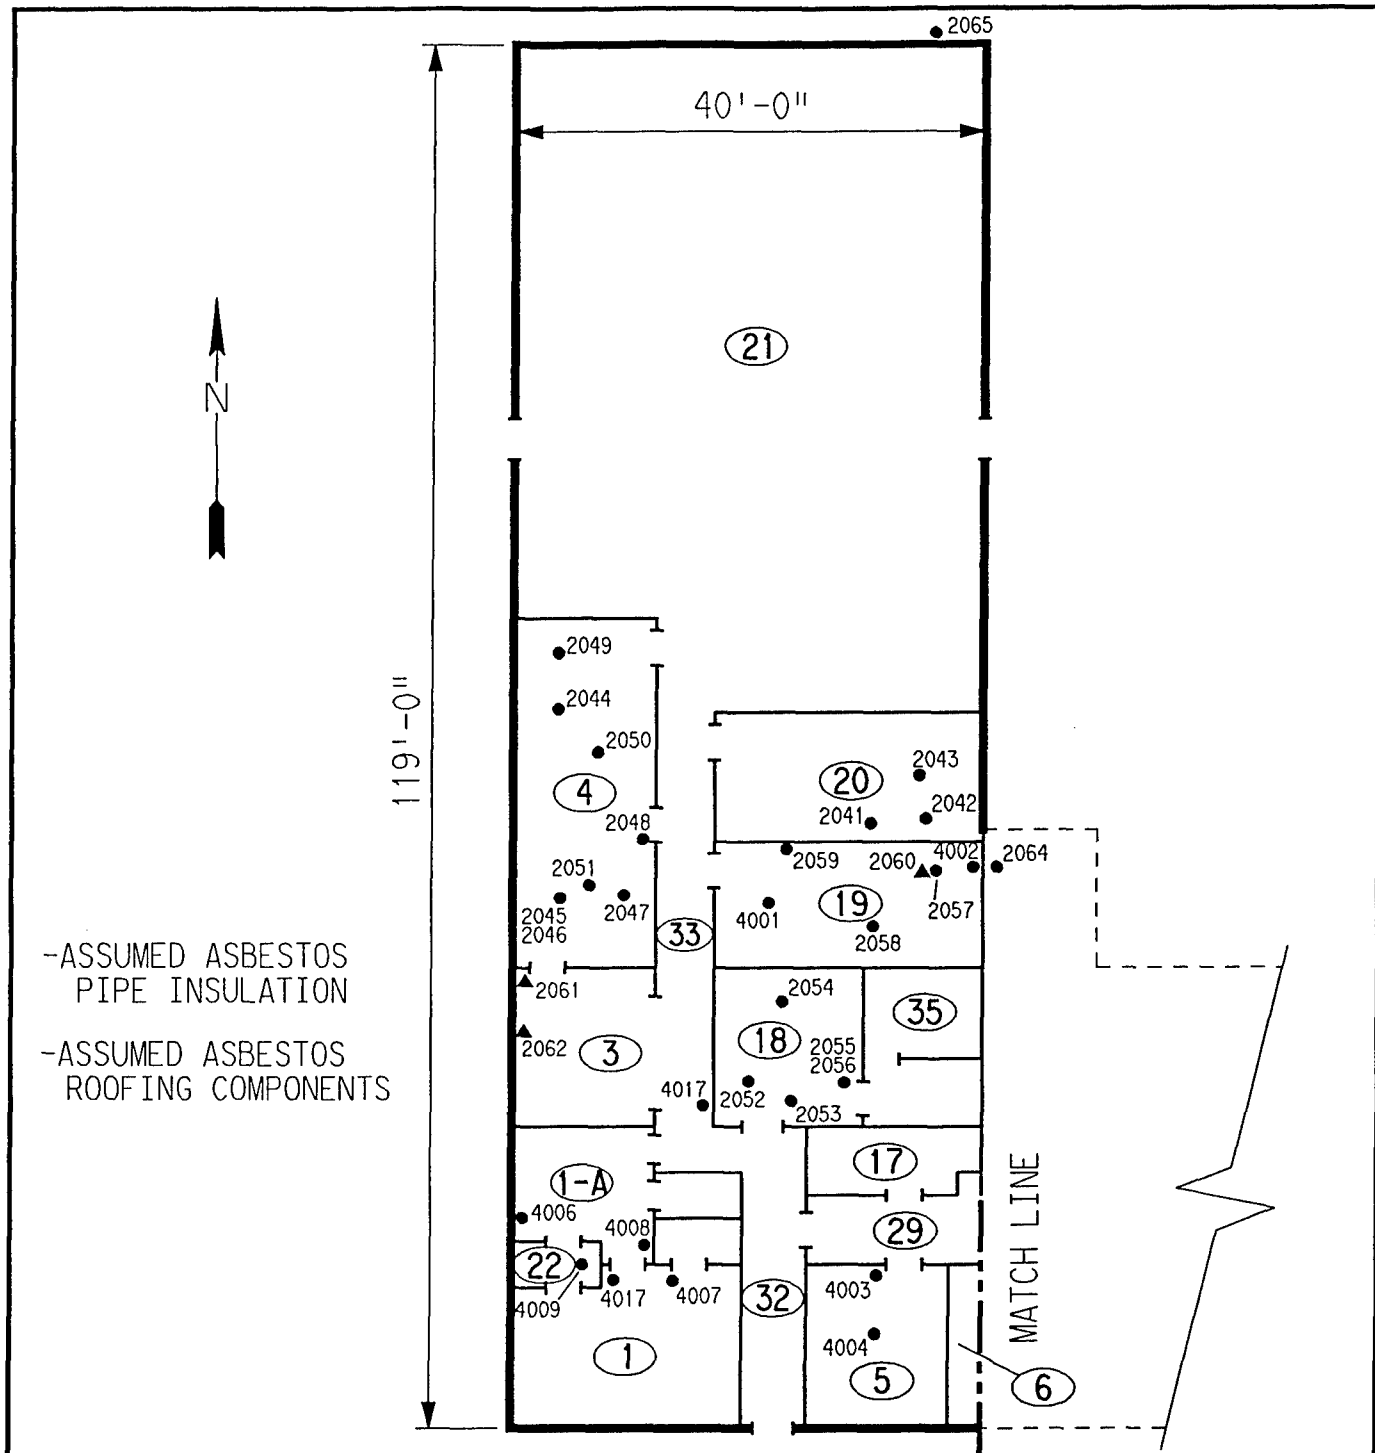
The general condition of ACM present was observed to be good with the noted exceptions above. Pipe insulations were observed to be friable, while other ACMs were nonfriable. ACM debris in the attic, and ACM pipe insulation should be removed prior to performance of maintenance work in these areas.

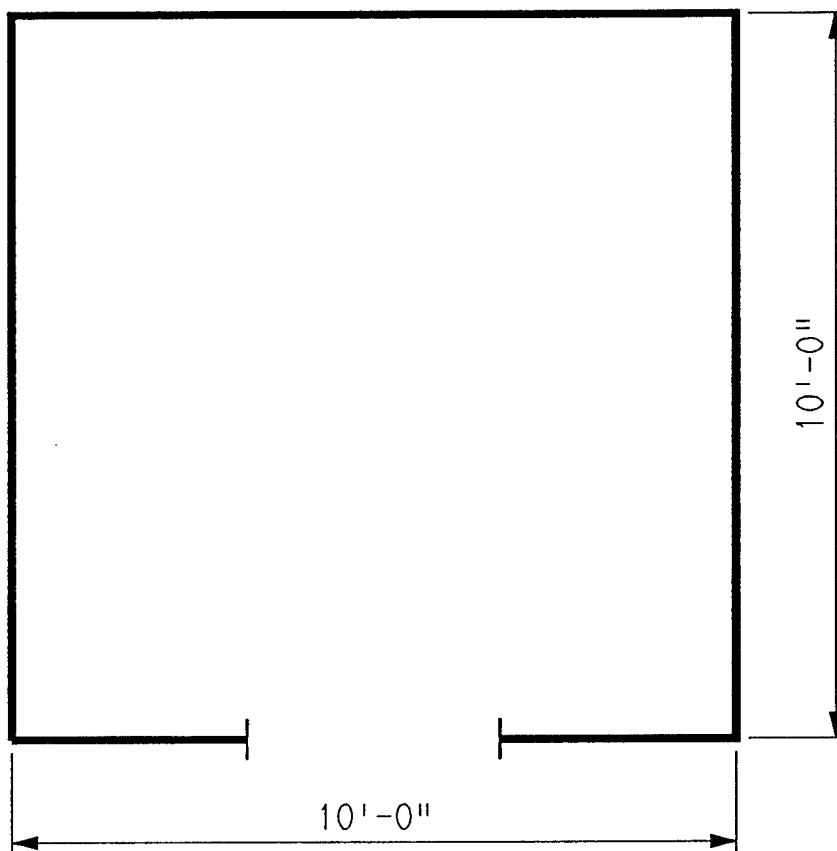
ACM was observed to be nonfriable and in good condition. This ACM is not considered to be a significant environmental concern.

ASSUMED ASBESTOS ROOFING COMPONENTS

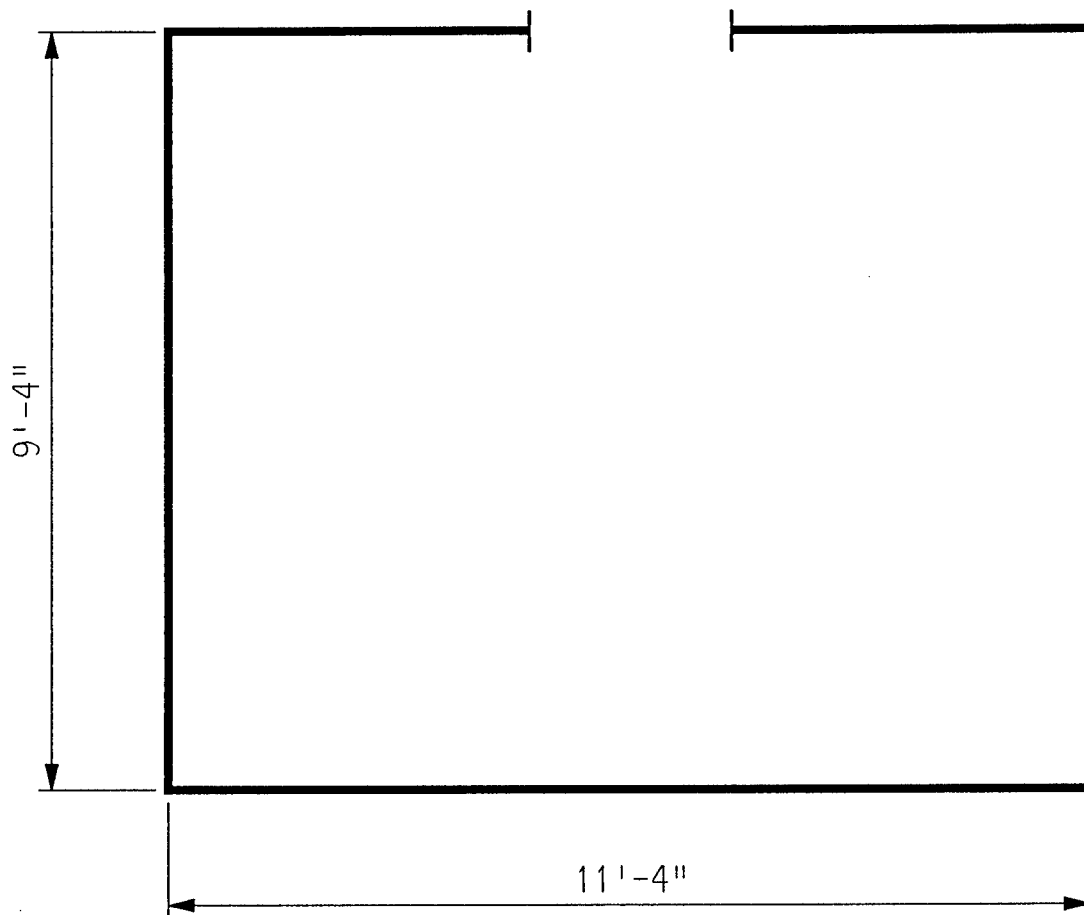
The general condition of ACM present was observed to be good with the noted exceptions above. ACM observed was nonfriable.

ASSUMED ASBESTOS ROOFING COMPONENTS  
 ASSUMED ASBESTOS CEMENT BOARD INSULATORS

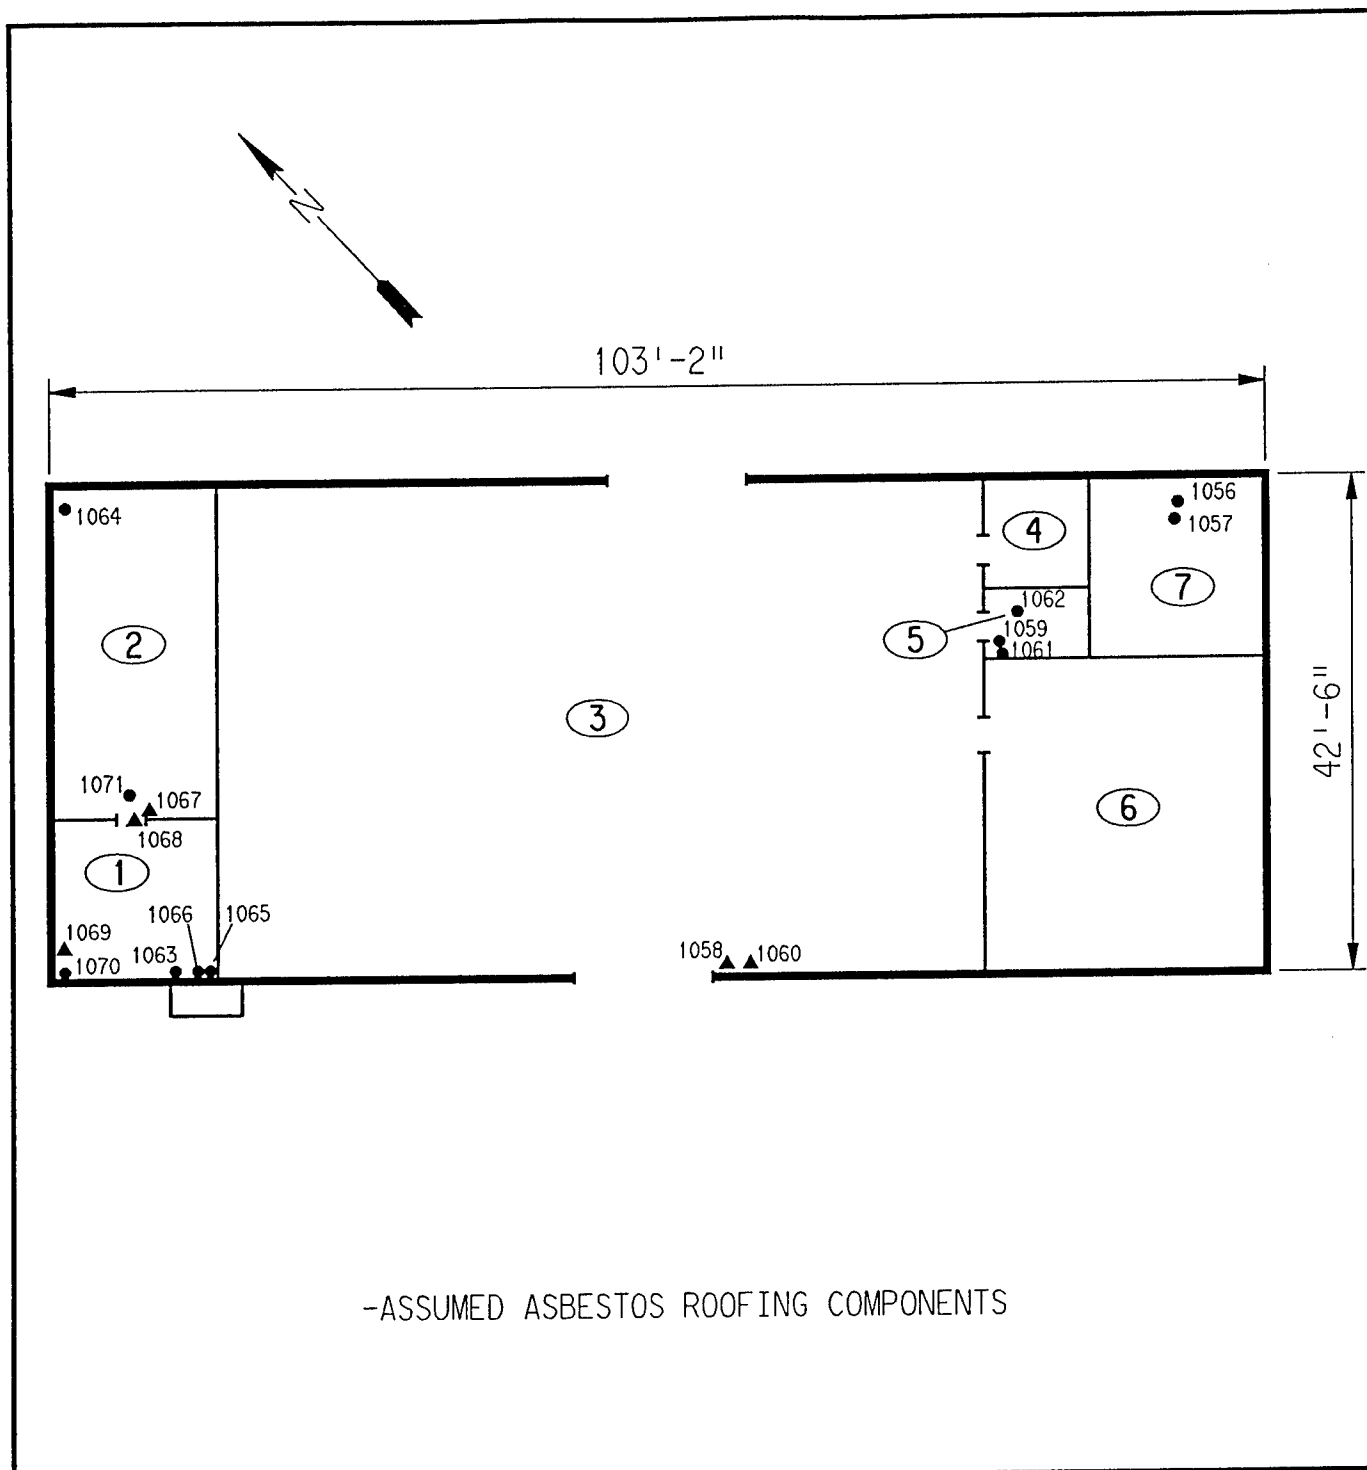
The general condition of ACM present was observed to be good with the exception of pipe insulations in the warehouse area as described above. ACM pipe insulation in the warehouse area was observed to be extremely friable and in need of prompt response action. The remaining ACM pipe insulation was observed to be friable, but in better condition. The remaining ACM was nonfriable.

The manual operation of a valve in the boiler room produces damage to an adjacent pipe fitting insulation. This fitting insulation was identified by the inspector as damaged and in need of immediate repair. The inspector also rated the potential for future damage as "high" because the valve is in such close proximity to the fitting.

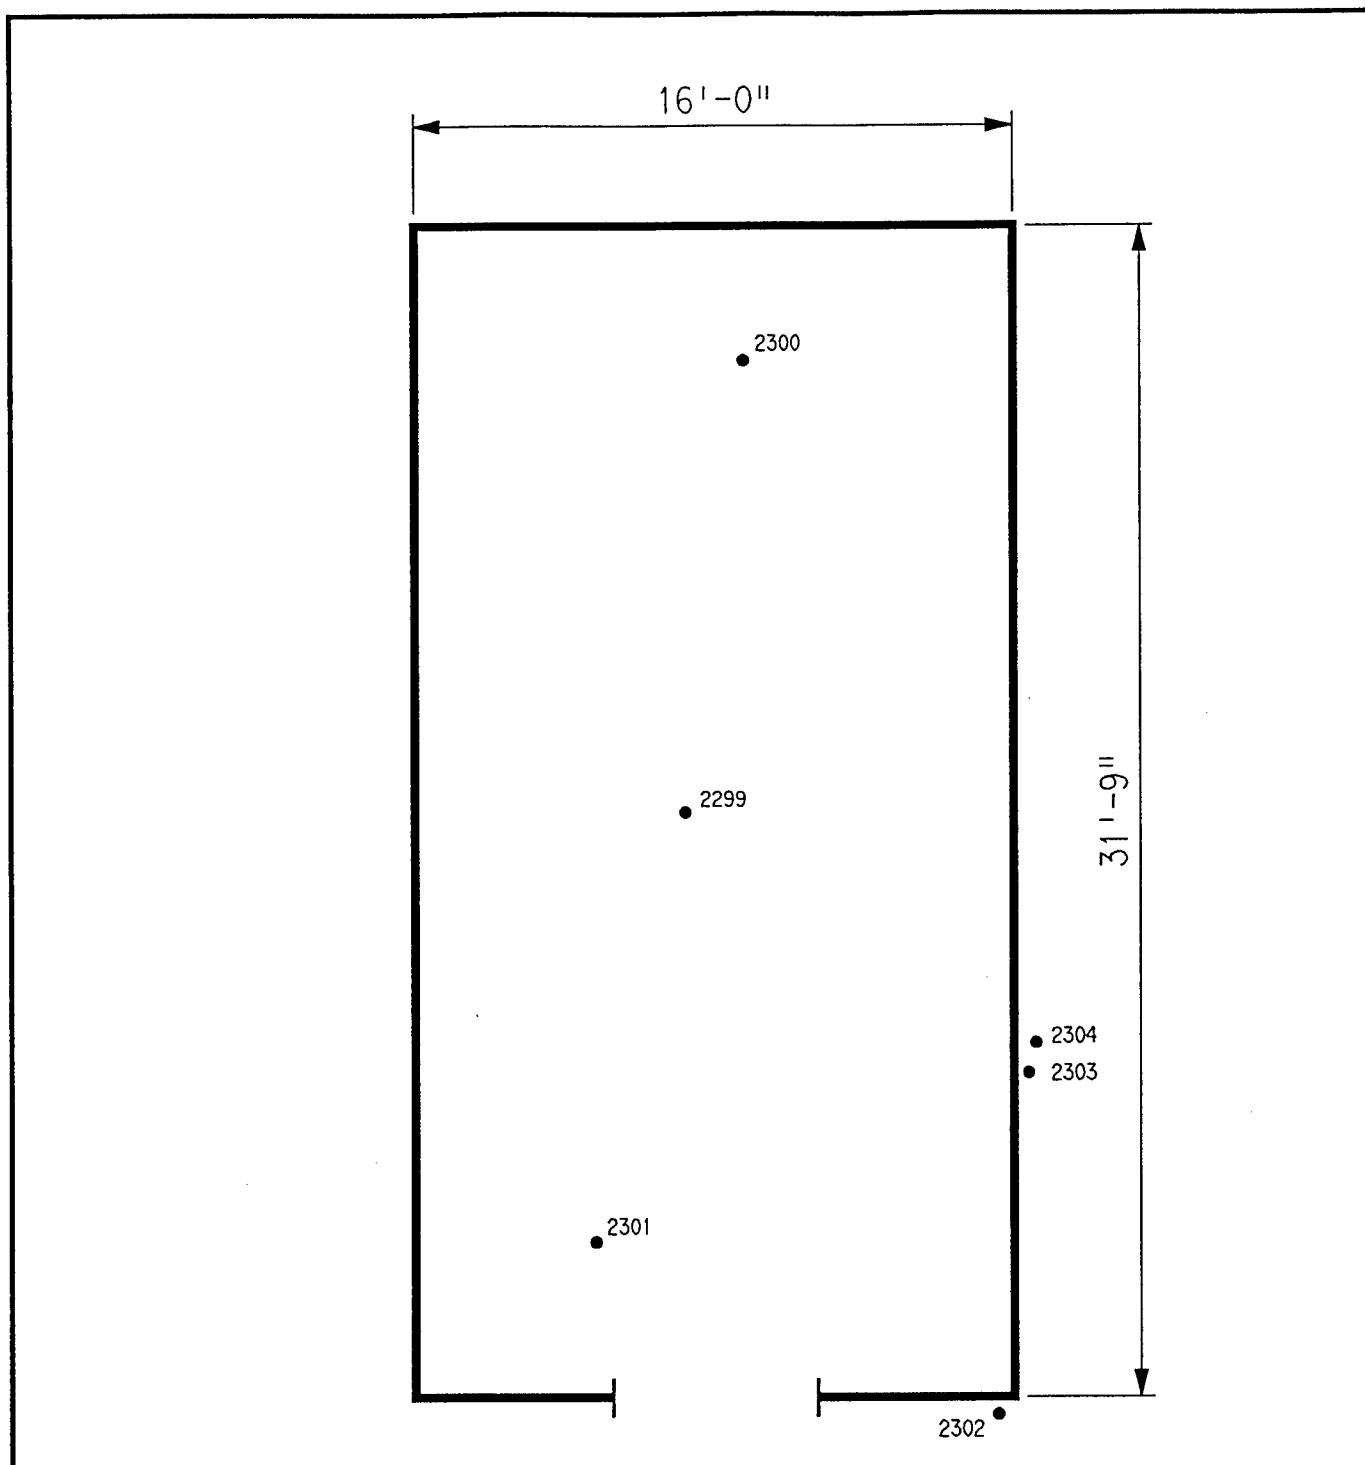
The cement wallboard and the ceiling plaster were both sampled. The cement wallboard was ACM but is nonfriable. The ceiling plaster was determined to be non ACM.

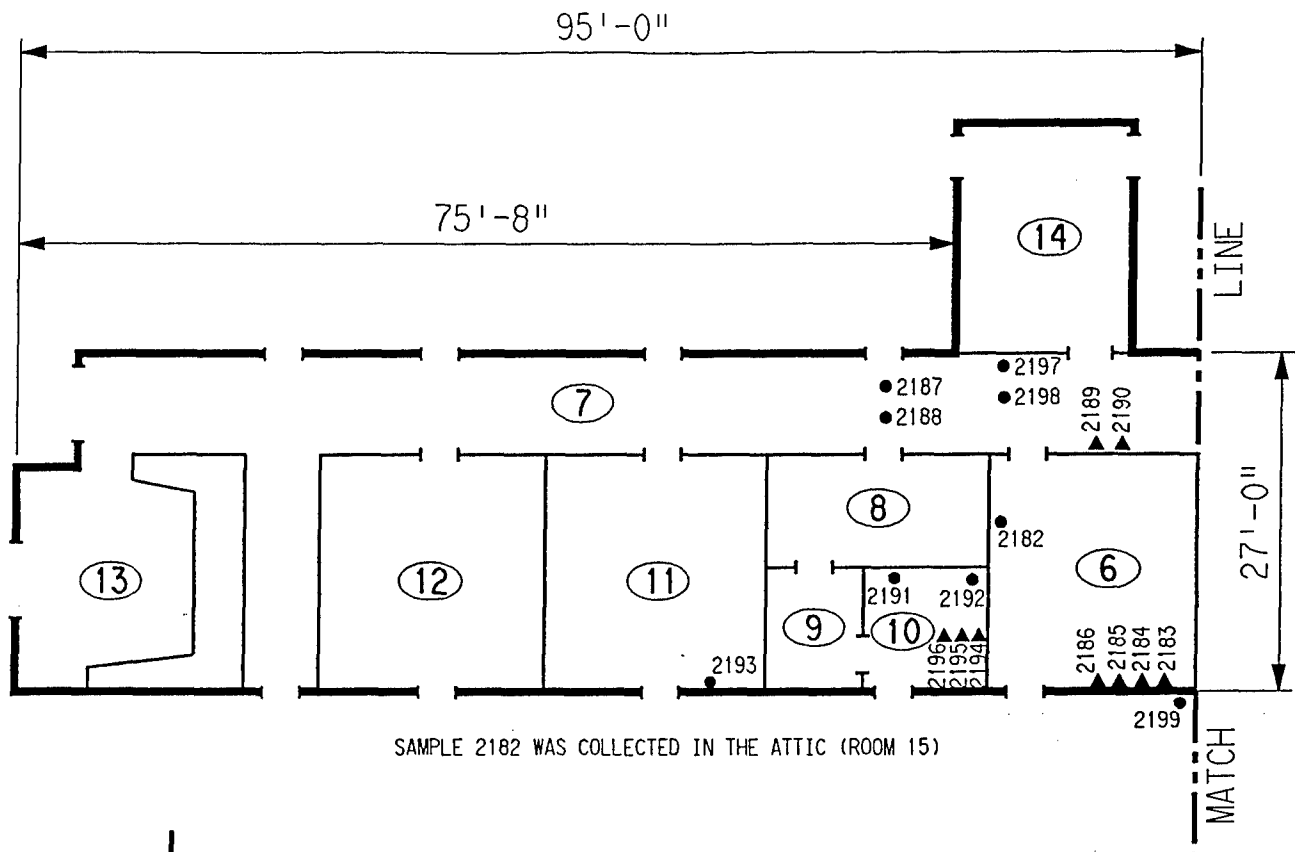
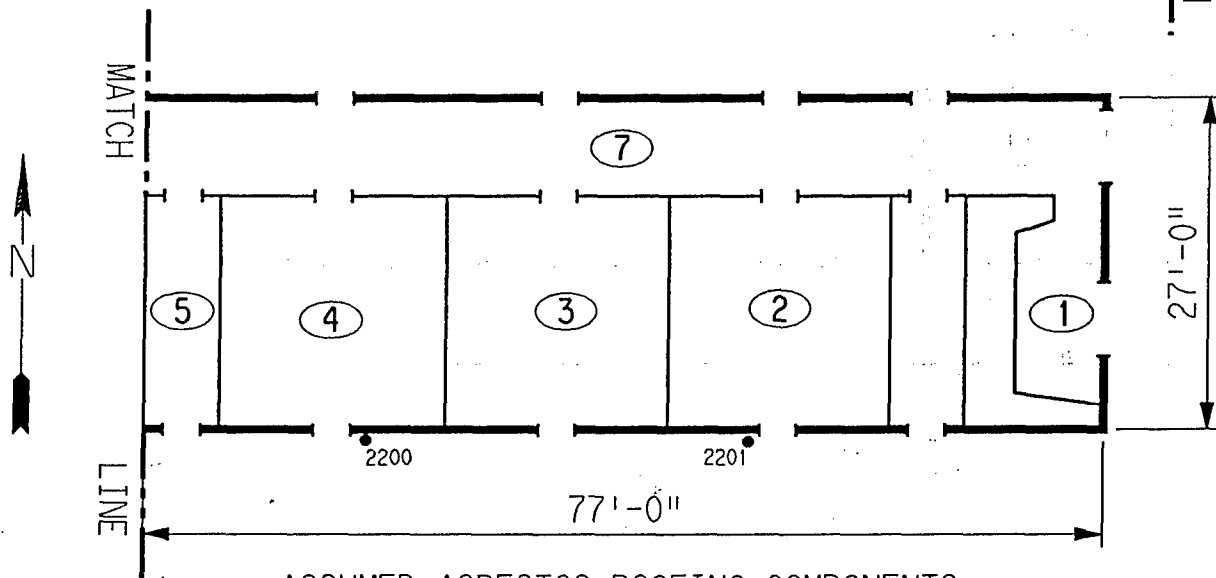
The general condition of ACM was observed to be good. ACM pipe insulations were observed to be friable and in need of minor repairs. The remaining ACM was observed to be nonfriable. The blown-in insulation in the attic was sampled and determined to be non-ACM. Because there was no ACM in the attic, it was not included in the functional space assessment.

### ASSUMED ASBESTOS ROOFING COMPONENTS

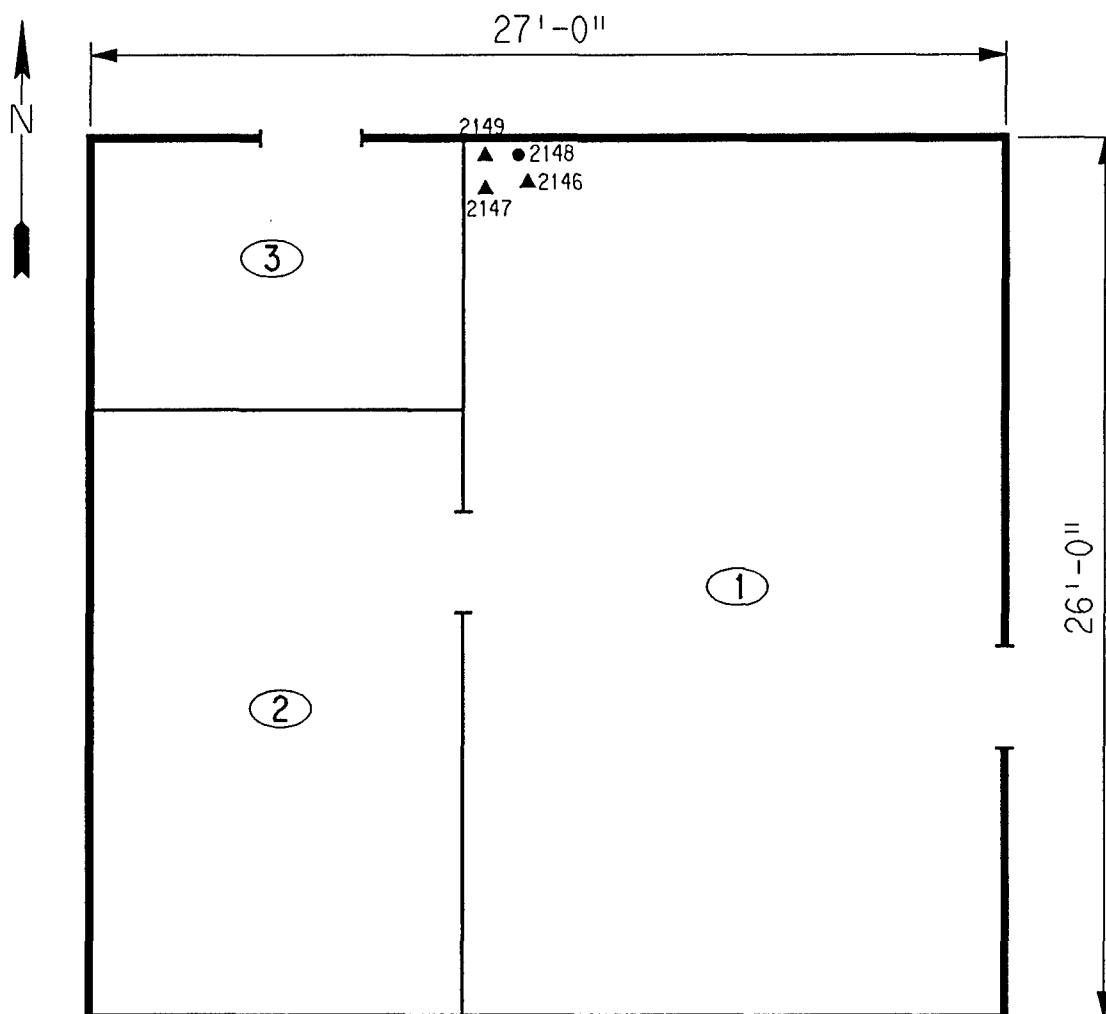
The general condition of ACM present was observed to be good. ACM pipe insulation observed was friable, while the remaining ACM observed was nonfriable.

The felt wrap pipe insulation was sampled and the analytical results were negative; however, if the insulation is removed, it should be re-sampled prior to disposal to ensure that there is no asbestos present. Other felt wrap pipe insulations in many buildings were determined to be ACM.
